In *Hot* Water

Experiences of Solar Hot Water Arizona

Arizona Solar Center, Inc. and Salt River Project

Special Site
Installation Findings
Lessons Learned
SRCC System Guidelines

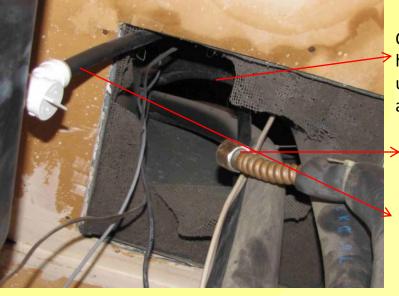
One foot square unconditioned attic

→Old lines not removed

Lines not insulated

System drains up

hole directly into

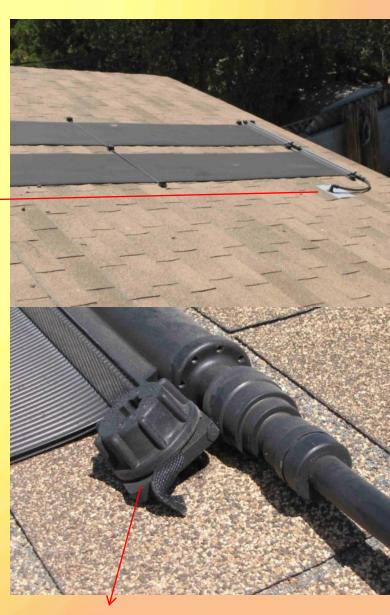
Tie-down tearing out of roof

Contractor had incorrect RoC license

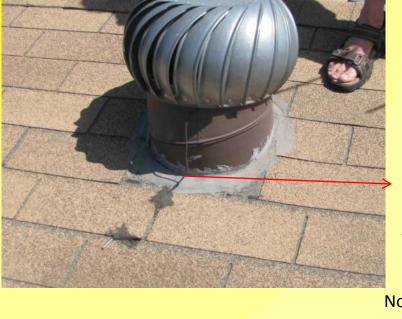
Sensor wire runs inside whirly bird

Tank not insulated ←

No insulation on lines ←

Hole knocked into wall for plumbing

No mixing valve

No Sikaflex

System drains up

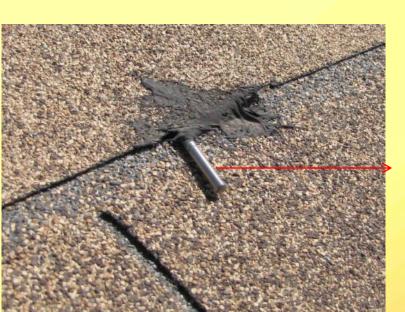
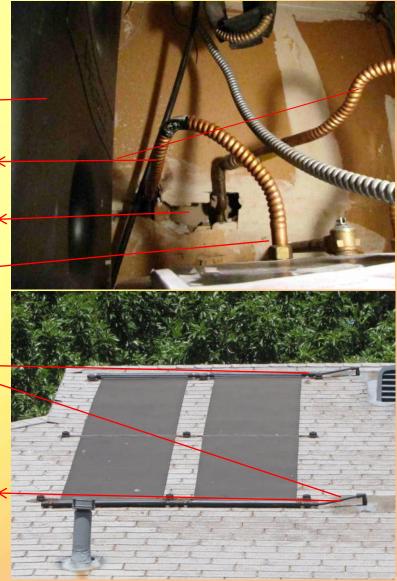
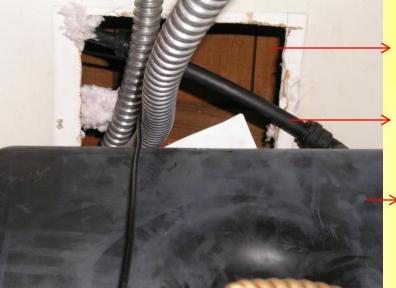
Open hole into attic, insulation falling into house

PEX not insulated

> Tank not insulated

Circulation module lines reversed

No Labels

Allen Key used for mixing ← valve

> Insulation from attic falling into ← house

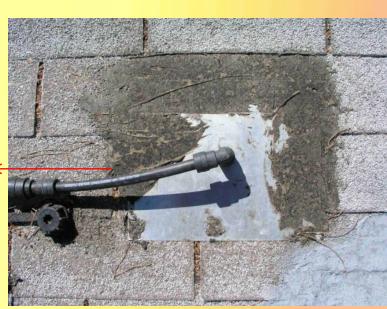
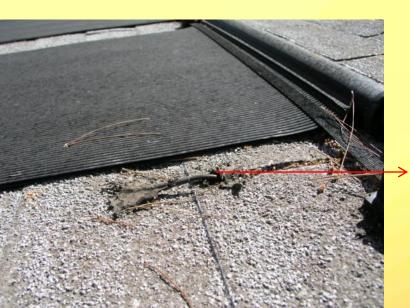
Sensor not installed correctly floating, note roof needs to be replaced

Multiple missed holes not correctly flashed on roof

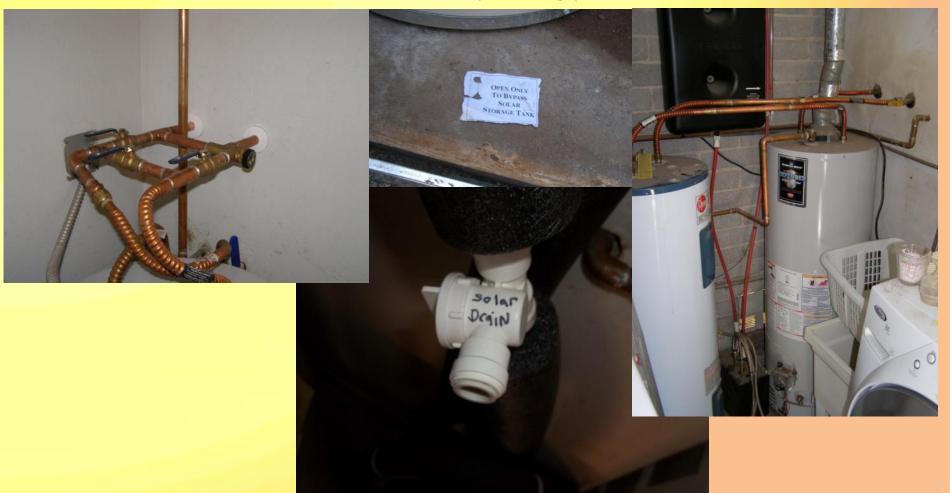
6.1.1.2 Isolation and Bypass

6.1.6.11 Piping System

The system is plumbed to the OG-300 drawing with all valves labeled showing normal operating position.

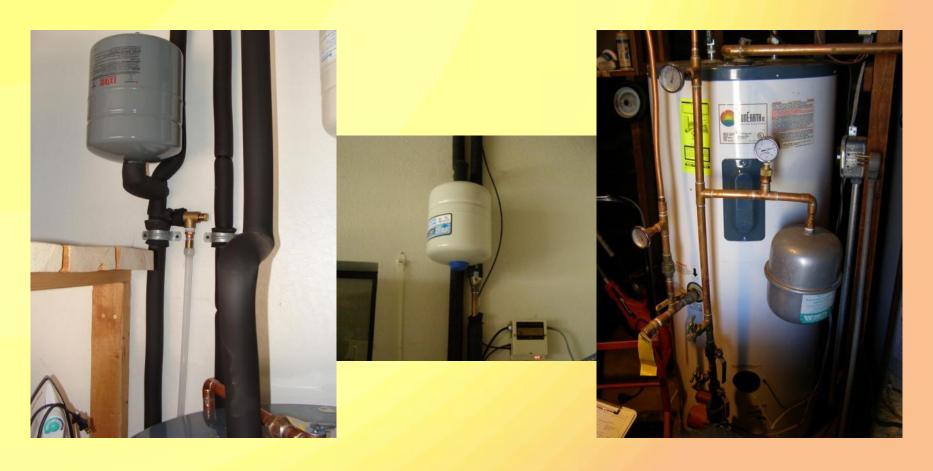
6.1.1.3 Expansion tanks Are expansion tanks installed and properly supported

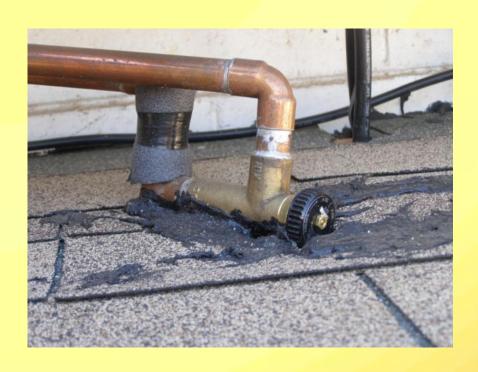
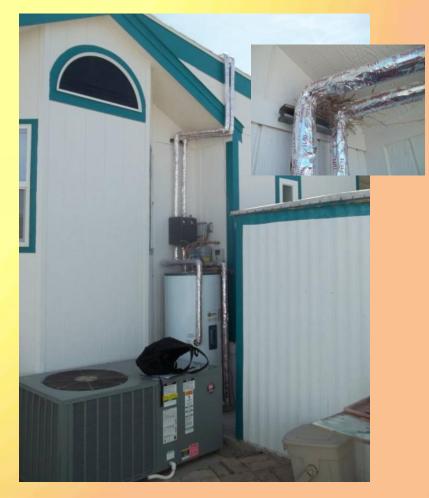
6.1.1.11 Airborne Pollutants

6.1.2.2 UV Radiation

6.2.2 Solar Degradation

Are components protected from the elements. i.e. Ozone, Moisture, UV

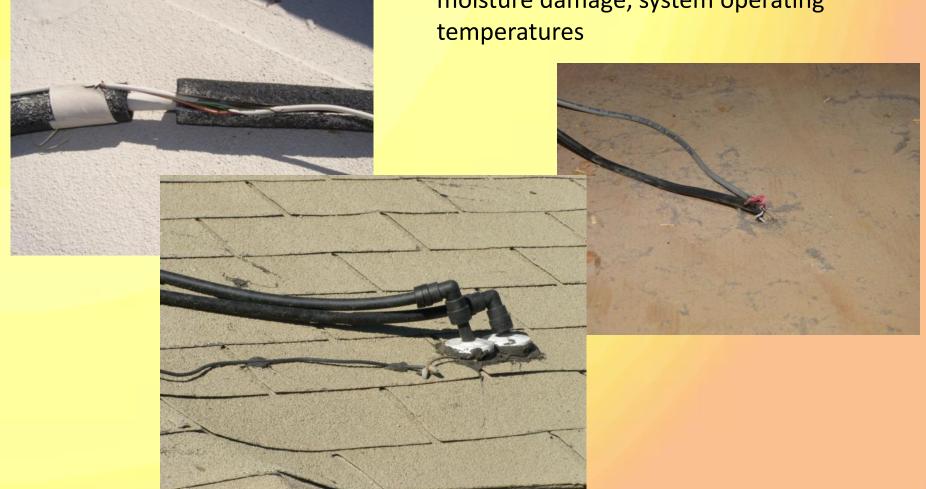
6.1.5.5 Control lines and Sensors

Degradation from the environment or system. Incorrect wire sheathing, moisture damage, system operating temperatures

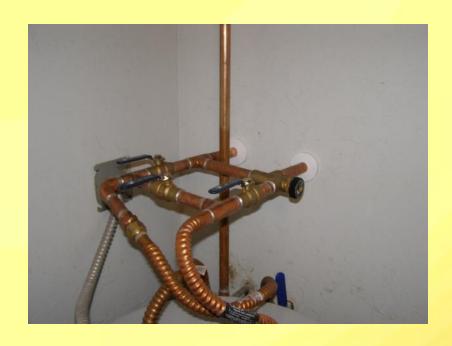
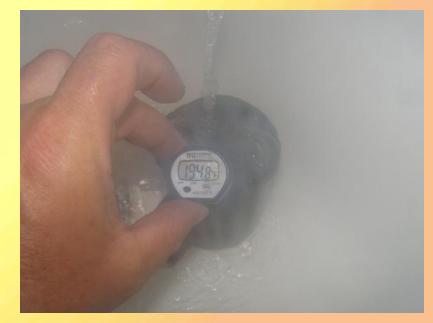
6.1.5.6 Temperature Control

Mixing valves need to be installed to the OG-300 drawing. Need to be installed to the manufactures guidelines

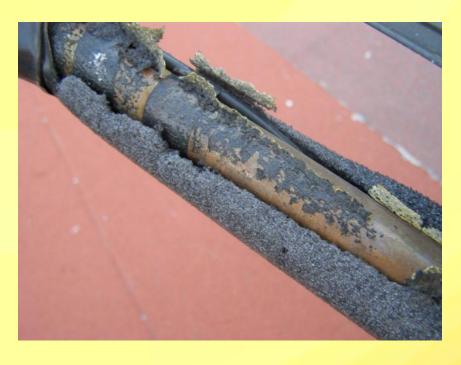
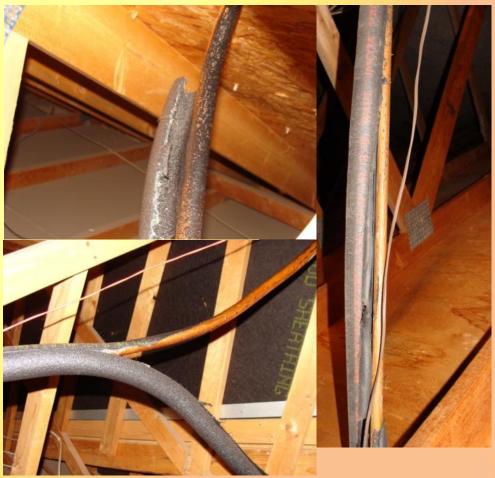
6.1.6.3 Insulation

Needs to be a high temperature EPDM or fiber type based insulation with an R2.6 or better. Needs to conform to 6.1.1.11 Airborne Pollutants, 6.1.2.2 UV Radiation, 6.2.2 Solar Degradation

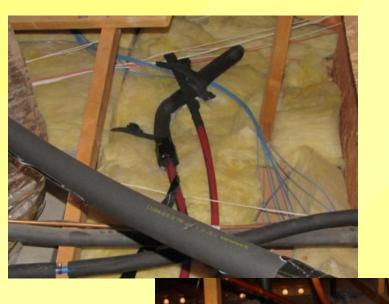
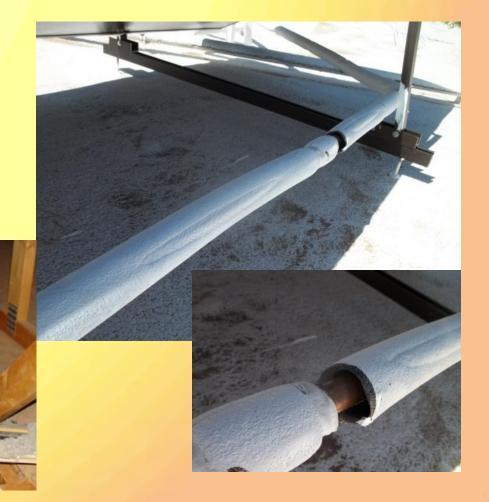
6.2.4 Incompatible Materials

Incorrect Piping like PEX on a drainback at the collector outlet

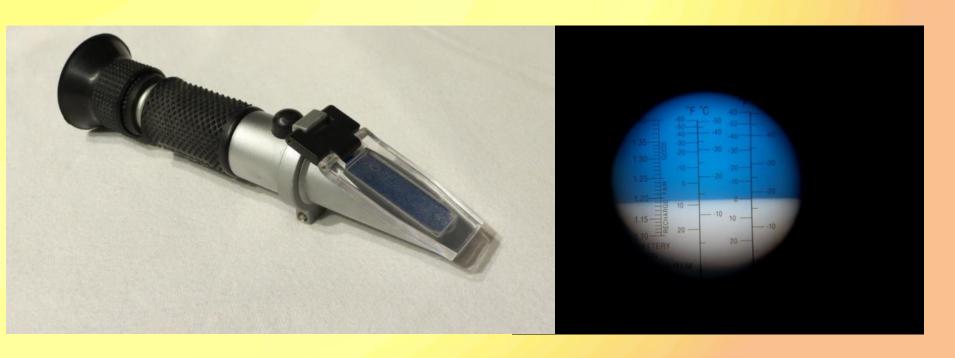
6.2.5 Freeze Protection

Refractometer is used to make sure that glycol is present in the system to the lowest recorded historical low temperature

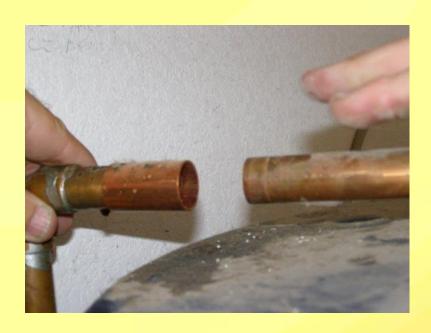
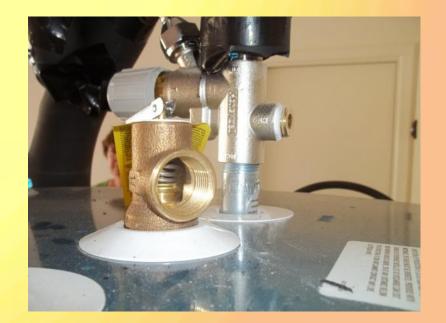
6.3.5 High Temperature Control

6.3.16 Pressure Relief

PV powered systems have a high temperature shut off
Pressure relief devices are installed to the OG-300 drawing and set below system maximum design pressure

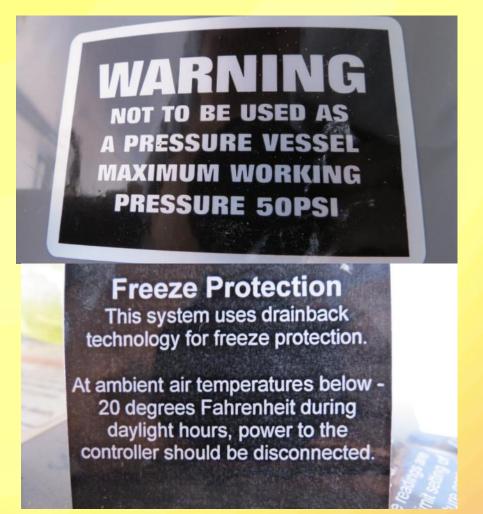
6.3.7 Fluid Safety Labeling

Labels to the manufactures and OG-300 guidelines are met

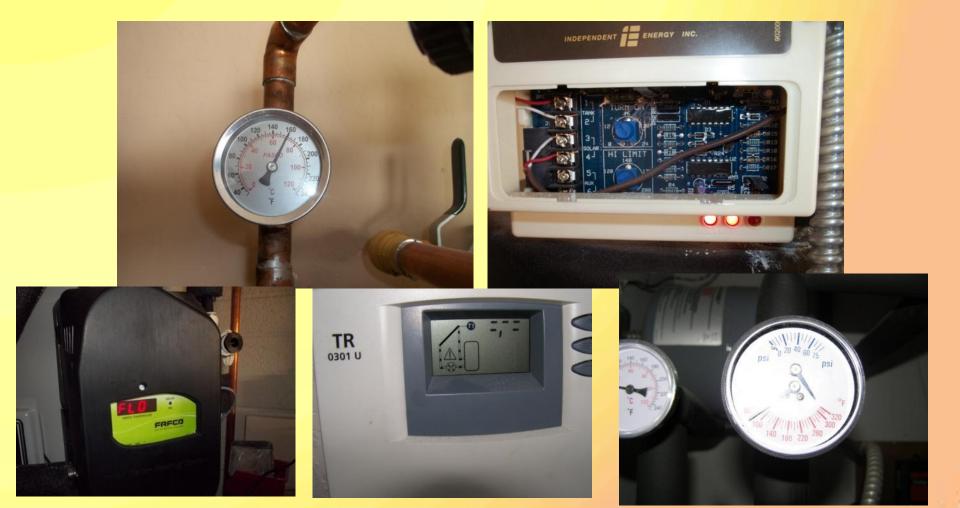
6.4.1 Operating Indicators

Working visual indicators to the manufactures and OG-300 drawing are present

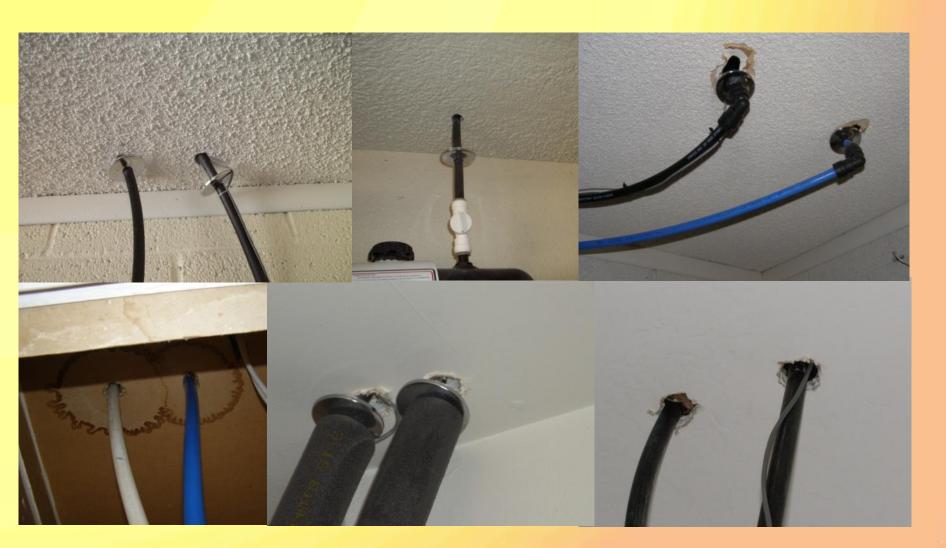
6.5.1 Fire Stopping

Use it!

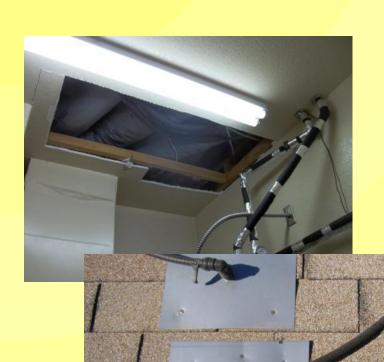
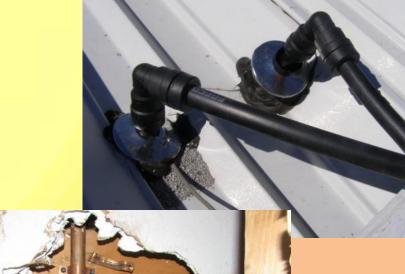
6.5.5 Building Penetrations

Correctly incorporated flashings and sealants in joists, members, wall systems

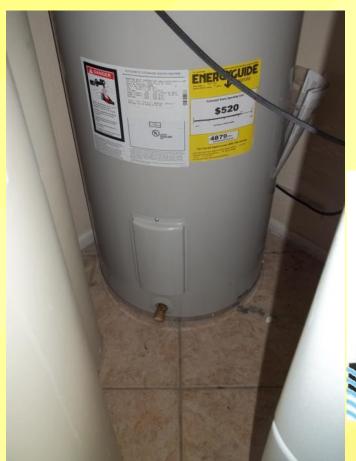
6.5.6 Water Damage

Water tanks in or above a conditioned space shall have a drip pan with a drain line to a safe location

- Waivers
- Water Alarms

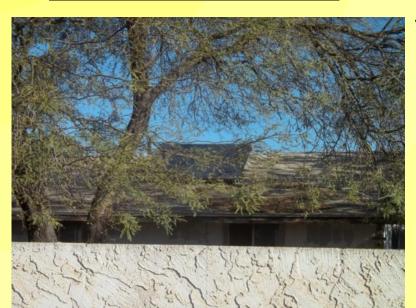
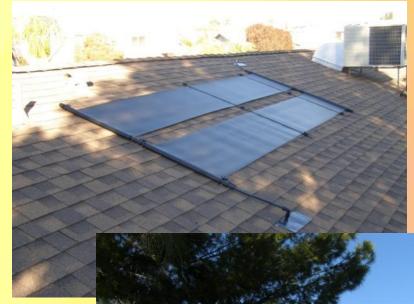
6.5.13 Shading of Collector

Collectors will be substantially un-shaded year round

Upper around 14:00, right around 15:30

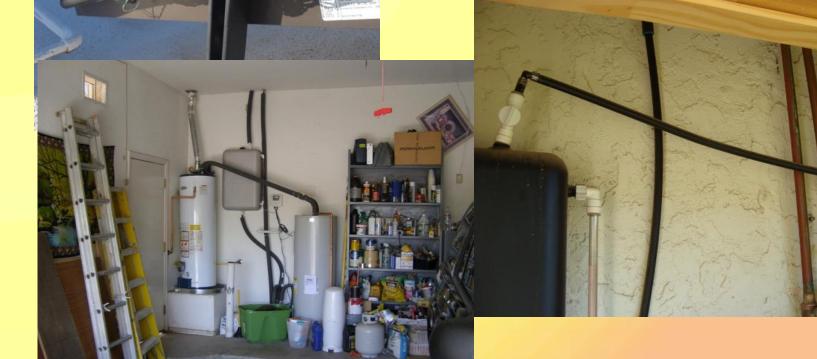
6.5.14 Pipe and Component Supports

Piping will conform to the IPC Table 308.5 for hanger spacing.

Compression or damage to insulation is to be avoided

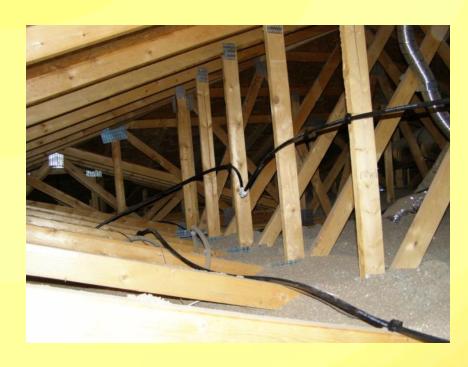
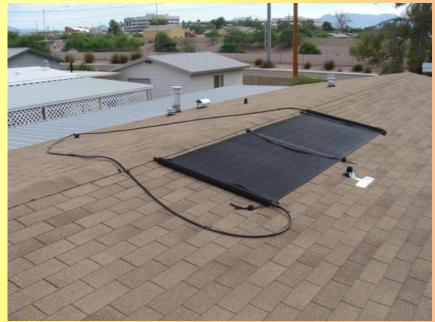
6.5.15 Pitch or Angle of Piping Insulation

Collectors and piping is pitched in a manner to permit evacuation of fluids on drainback systems

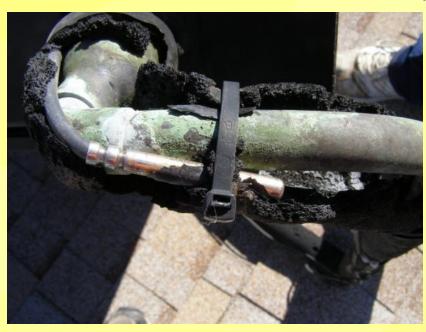
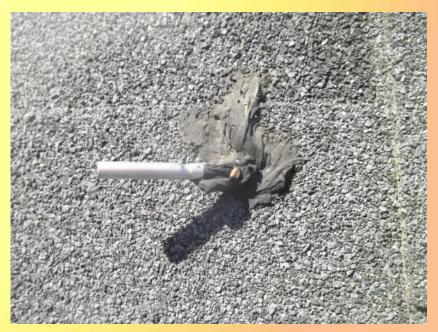
6.5.18 Control Sensor Installation

Wind, moisture, UV, high voltage wiring, hot piping, electrical tape, zip ties, etc...
